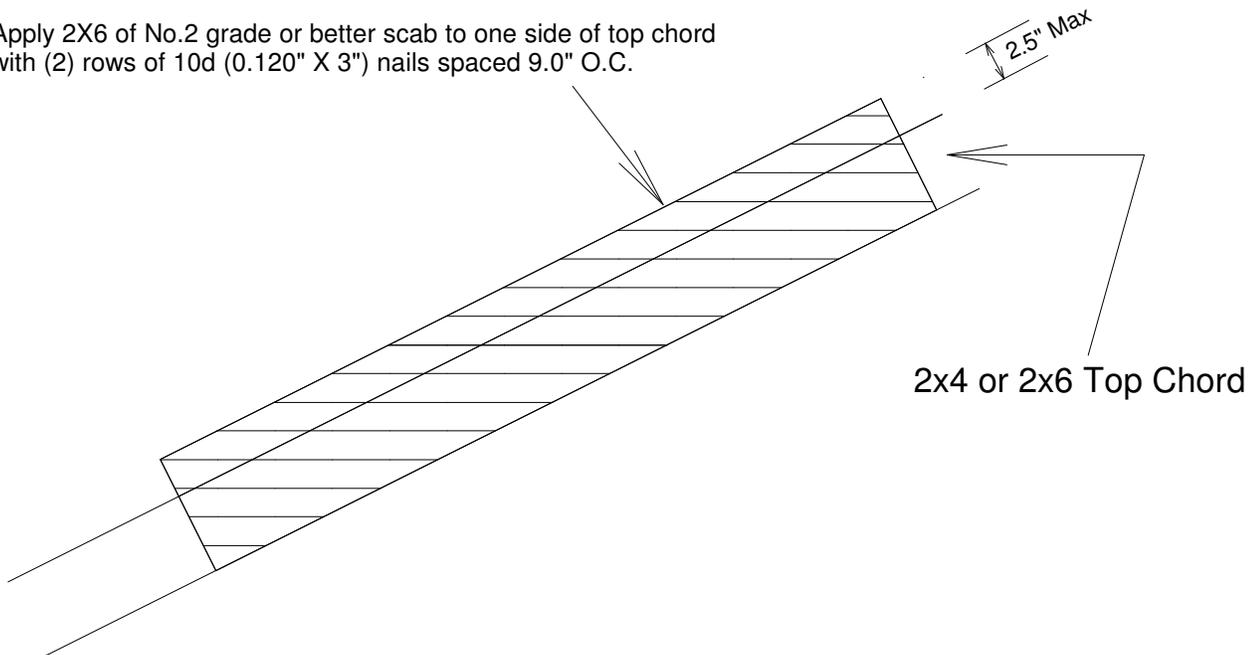
This repair to be used only with trusses (spans less than 40') spaced 24" o.c. maximum and having pitches between 5/12 and 10/12 and total top chord loads less than 50 psf. Trusses not fitting these criteria should be examined individually.

Apply 2X6 of No.2 grade or better scab to one side of top chord with (2) rows of 10d (0.120" X 3") nails spaced 9.0" O.C.
