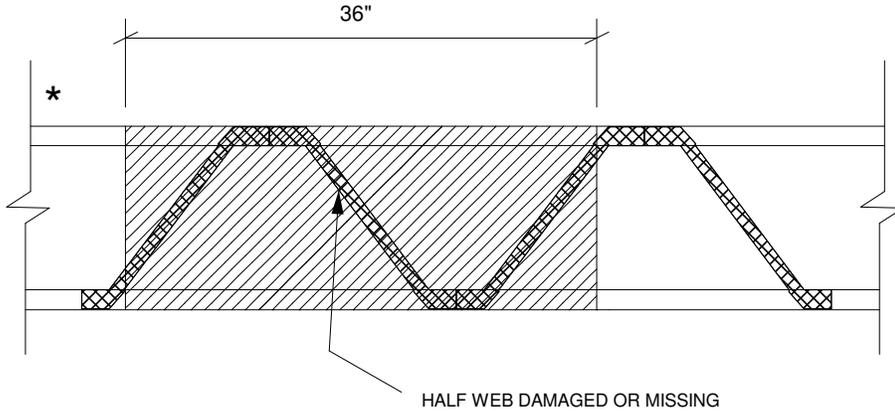
REFER TO INDIVIDUAL TRUSS DESIGN FOR PLATE SIZES, LUMBER GRADES AND FORCE IN PANEL TO BE REPAIRED.

\* IF FIRST HALF WEB OR FULL WEB IS DAMAGED, GUSSET SHALL START FLUSH WITH END OF TRUSS.

ATTACH 3/4" PLYWOOD OR OSB GUSSET (23/32" APA RATED SHEATHING 48/24 EXP 1) TO EACH SIDE OF TRUSS WITH CONSTRUCTION QUALITY ADHESIVE AND ONE ROW OF 10d (0.131" X 3") NAILS SPACED 3" O.C. FROM EACH FACE.

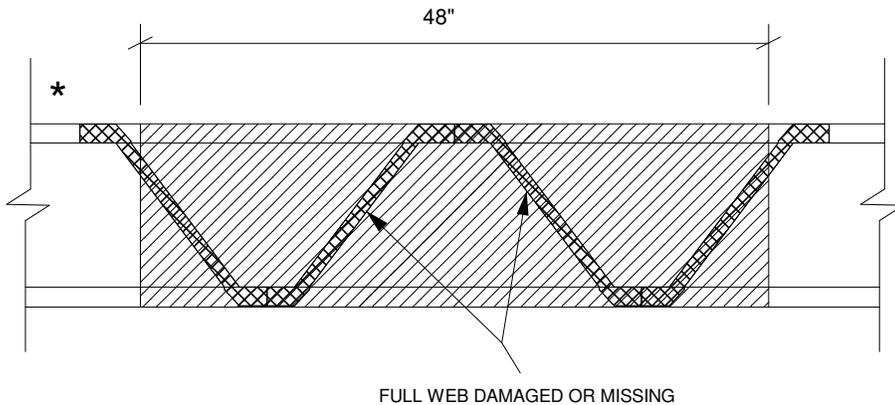
MAXIMUM ALLOWABLE FORCE IN DAMAGED WEB	
CHORD SPECIES	MAX. FORCE
SP	1050
SPF	966
DF	1022
HF	980

ATTACH 3/4" PLYWOOD OR OSB GUSSET (23/32" APA RATED SHEATHING 48/24 EXP 1) TO EACH SIDE OF TRUSS WITH CONSTRUCTION QUALITY ADHESIVE AND ONE ROW OF 10d (0.131" X 3") NAILS SPACED 3" O.C. FROM EACH FACE.
