Laboratory Acoustical Test Report

FC23-0780R1

Impact Insulation Class and Sound Transmission Class

Shaw Bethany Place Carpet

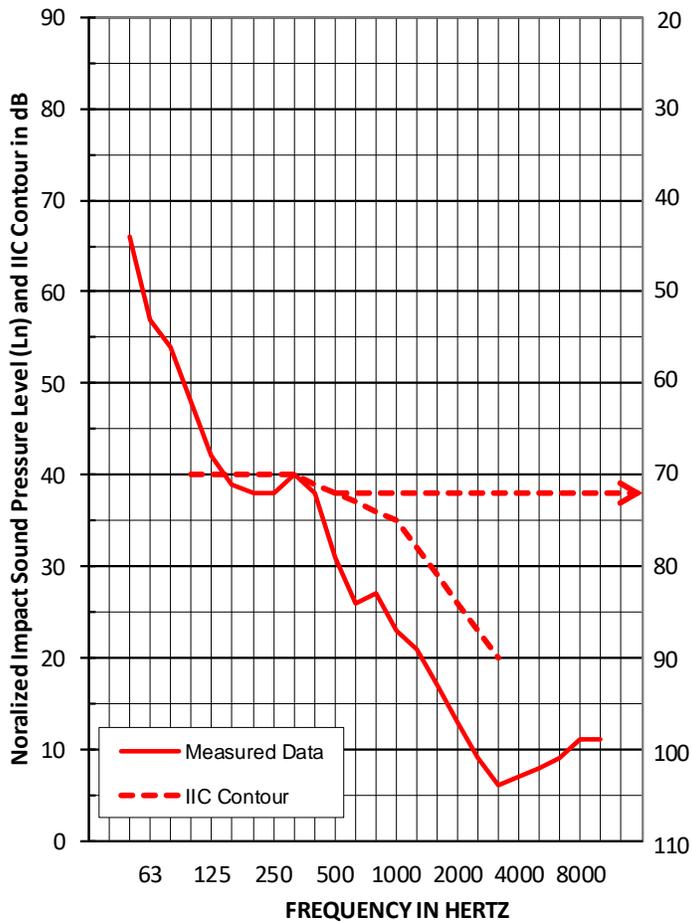
Impact Insulation Class Test FC23-0780: IIC 72

Carpet	19.1 mm Shaw Bethany Place
Carpet Pad	9.5 mm Shaw
Subfloor	Gypsum Concrete
Subfloor Panel	18.3 mm Oriented Strand Board Sheathing
Truss	235 mm MiTek PS10 Truss
Insulation	88.9 mm Johns Manville Unfaced R-11 Fiberglass Insulation
Resilient Channel	12.7 mm ClarkDietrich RC Deluxe™ Resilient Channel
Gypsum Panel	15.9 mm National Gypsum Type C Gypsum Panel

Test Date: February 25, 2023
 Construction Date: February 25, 2023
 Test Specimen Area: 11 sq.m.
 Receiving Room Volume: 156 cu.m.
 Receiving Room Temperature: 17.5-17.6 degrees C
 Receiving Room Relative Humidity: 55-55 percent

Freq	95% Confidence	
	Limit	Ln
50	1.6	66
63	2.3	57
80	2.5	54
100	1.0	48
125	1.2	42
160	1.1	39
200	1.1	38
250	0.7	38
315	0.4	40
400	0.5	38
500	0.4	31
630	0.4	26
800	0.3	27
1000	0.4	<u>23</u>
1250	0.2	<u>21</u>
1600	0.3	<u>17</u>
2000	0.5	<u>13</u>
2500	0.4	<u>9</u>
3150	0.4	<u>6</u>
4000	0.4	<u>7</u>
5000	0.4	<u>8</u>
6300	0.4	<u>9</u>
8000	0.5	<u>11</u>
10000	0.5	<u>11</u>

All tests were conducted in accordance with ASTM E492, "Standard Test Method for Laboratory Measurement of Impact Sound Transmission through Floor-Ceiling Assemblies Using the Tapping Machine." The IIC is a single-number rating derived from the Impact Sound Pressure Level in accordance with ASTM E989, "Standard Classification for Determination of Impact Insulation Class (IIC)." Results are presented above.

95% confidence intervals represent uncertainty for microphone averaging, not tapping positions.

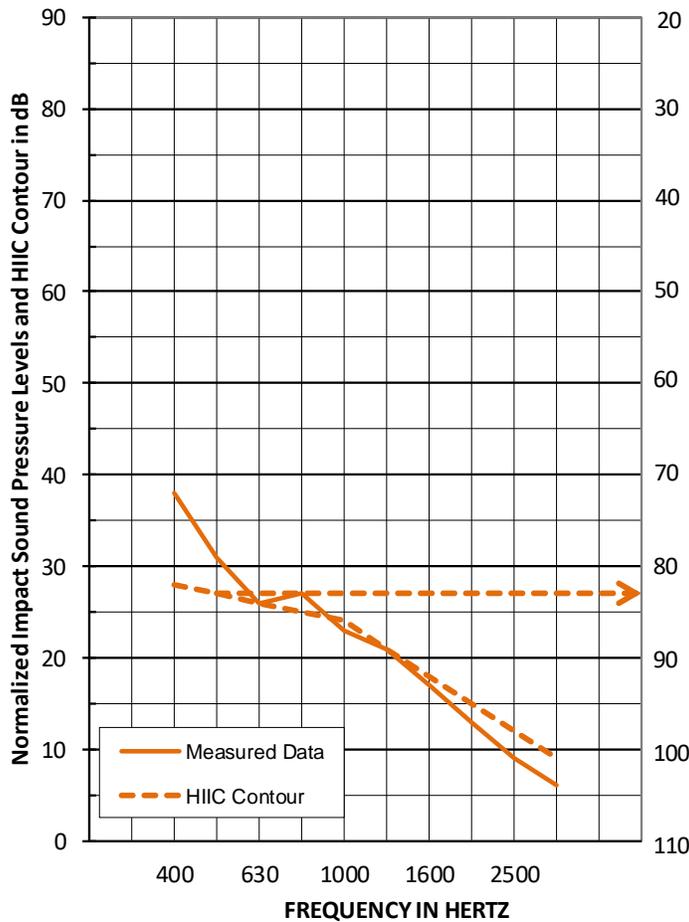
High-frequency Impact Insulation Class Test FC23-0780: HIIC 83

Carpet	19.1 mm Shaw Bethany Place
Carpet Pad	9.5 mm Shaw
Subfloor	Gypsum Concrete
Subfloor Panel	18.3 mm Oriented Strand Board Sheathing
Truss	235 mm MiTek PS10 Truss
Insulation	88.9 mm Johns Manville Unfaced R-11 Fiberglass Insulation
Resilient Channel	12.7 mm ClarkDietrich RC Deluxe™ Resilient Channel
Gypsum Panel	15.9 mm National Gypsum Type C Gypsum Panel

Test Date: February 25, 2023
 Construction Date: February 25, 2023
 Test Specimen Area: 11 sq.m.
 Receiving Room Volume: 156 cu.m.
 Receiving Room Temperature: 17.5-17.6 degrees C
 Receiving Room Relative Humidity: 55-55 percent

95% Confidence		
Freq	Limit	Ln
400	0.5	38
500	0.4	31
630	0.4	26
800	0.3	27
1000	0.4	<u>23</u>
1250	0.2	<u>21</u>
1600	0.3	<u>17</u>
2000	0.5	<u>13</u>
2500	0.4	<u>9</u>
3150	0.4	<u>6</u>

The HIIC is the High-frequency Impact Insulation Class and is meant to assess the high-frequency impact noise on a floor-ceiling assembly. The higher the value, the better the floor, meaning less noise from high-frequency impacts in the space below.

All tests were conducted in accordance with the requirements of ASTM E492, "Standard Test Method for Laboratory Measurement of Impact Sound Transmission through Floor-Ceiling Assemblies Using the Tapping Machine," using ASTM E3222 "Standard Classification for Determination of High-frequency Impact Sound Ratings" to calculate the High-frequency Impact Insulation Class (HIIC). Results are presented above.

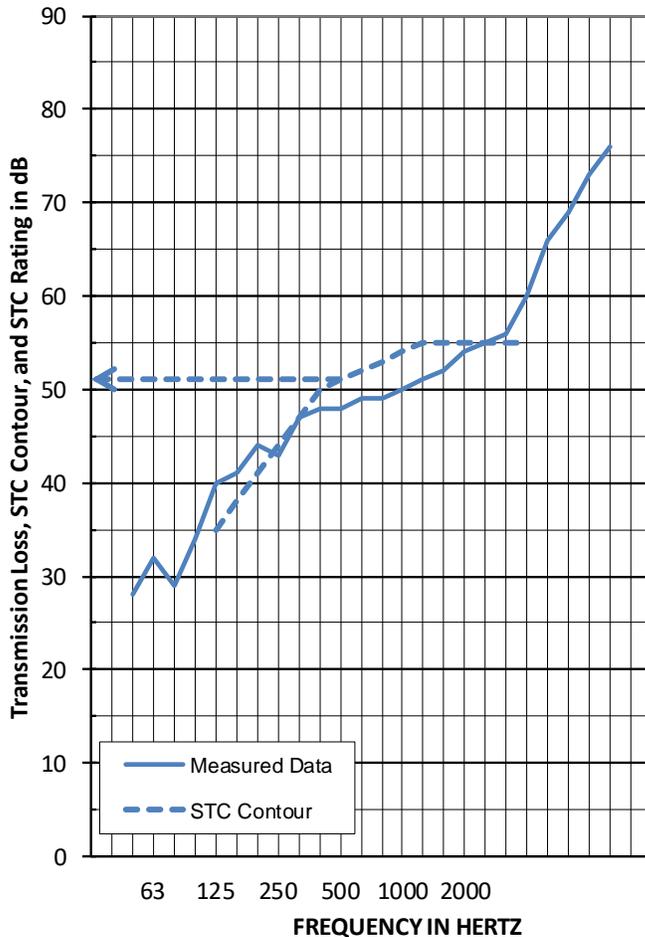
Sound Transmission Class Test FC23-0780: STC 51

Carpet	19.1 mm Shaw Bethany Place
Carpet Pad	9.5 mm Shaw
Subfloor	Gypsum Concrete
Subfloor Panel	18.3 mm Oriented Strand Board Sheathing
Truss	235 mm MiTek PS10 Truss
Insulation	88.9 mm Johns Manville Unfaced R-11 Fiberglass Insulation
Resilient Channel	12.7 mm ClarkDietrich RC Deluxe™ Resilient Channel
Gypsum Panel	15.9 mm National Gypsum Type C Gypsum Panel

Test Date: February 25, 2023
 Construction Date: February 25, 2023
 Test Specimen Area: 11 sq.m.
 Source/Receiving Room Volume: 190/156 cu.m.
 Source/Receiving Room Temperature: 16.9/17.5 degrees C
 Source/Receiving Room Relative Humidity: 55/55 percent

Freq	TL
50	28
63	32
80	29
100	34
125	40
160	41
200	44
250	43
315	47
400	48
500	48
630	49
800	49
1000	50
1250	51
1600	52
2000	54
2500	55
3150	56
4000	60
5000	66
6300	69
8000	<u>73</u>
10000	<u>76</u>

All tests were conducted in accordance with ASTM E90, "Standard Test Method for Laboratory Measurement of Airborne Sound Transmission Loss of Building Partitions," using the single-direction method. STC is a single-number rating derived from measured values of Sound Transmission Loss through a test specimen in accordance with ASTM E413, "Classification for Rating Sound Insulation." Results are presented above.

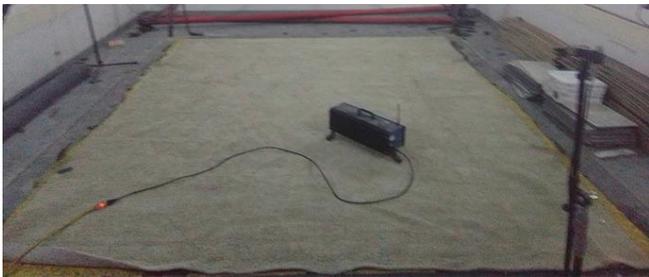
Photo 1: View of Source Chamber, carpet installation observed

- Carpet: Loose laid.
- Carpet pad: Loose laid.
- Gypsum concrete: Poured directly onto the subfloor underlayment, cured a minimum of 14 days. The gypsum panel had a closed cell foam perimeter isolation. No noticeable shrinkage or cracking was visible on the specimen.

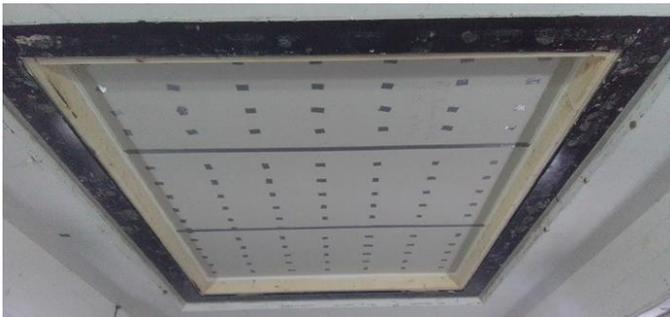
Photo 2: View of Receive Chamber, bottom of gypsum panel observed

- Resilient channel: Installed on 406 mm centers perpendicular to the trusses.
- Gypsum panel: Fastened to the channels on 203 mm centers with 31.8 mm Type S bugle head screws. The seams of the gypsum panels were sealed with Pecora AC-20 FTR caulk and covered with pressure sensitive tape.
